## **Forensic study of premature failures with unbonded concrete overlay on interstate 70 in Ohio**

**Abstract:** This paper presents the results and findings from a forensic investigation initiated in 2014 to identify the causes of premature failures on an unbonded concrete overlay (UBCO) on Interstate 70 in Madison County, Ohio. This project was constructed in 1999 and 2000. Premature distress, including transverse cracking, corner breaks and slab settlement began to appear in 2008. Falling weight deflectometer (FWD) and distress survey data were collected from the field during the investigation. MIT Scan was used to evaluate dowel alignment. Concrete samples were taken from the field and tested in the laboratory. HIPERPAV was used to evaluate early behaviour of the Portland cement concrete (PCC). Results of finite element analysis was used to help understand the mechanisms responsible for the premature distresses.

**Reference** to this paper should be made as follows: Zhu, J., Sargand, S., Green, R. and Khoury, I. (2018) 'Forensic study of premature failures with unbonded concrete overlay on interstate 70 in Ohio', *Int. J. Forensic Engineering*, Vol. 4, No. 1, pp.1–19.

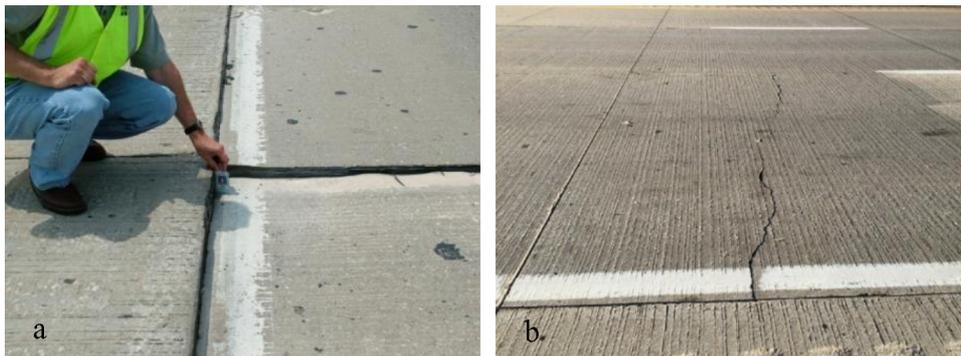
**Figure 1** (a) MAD-70 EB faulting (June 25, 2008) and (b) MAD-70 EB transverse cracking (March 30, 2015) (see online version for colours)

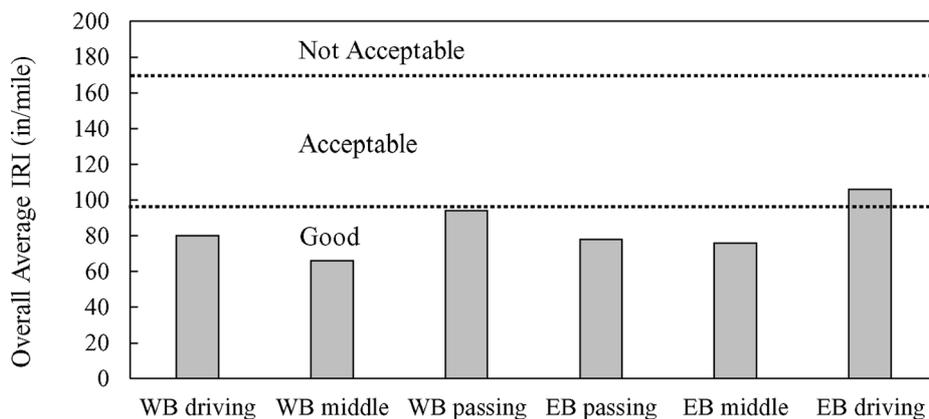
A Road Tester 3000 profiler was used to collect digital images and measurements of pavement condition and ride quality on May 22, 2015. The overall average international roughness index (IRI) of each lane is presented in Figure 3. Table 1 shows the correlation of IRI to pavement condition ratings (PCR). As can be seen from the graphs, overall IRI for most of the tested lanes was 'Good'. The only exception was the driving lane for MAD-70 which showed 'Acceptable' condition. The westbound lanes of MAD-70 are relatively smoother than the eastbound lanes.

**Figure 3** Average IRI on MAD-70, all lanes ( $1 \text{ in/mi} = 1.58 \times 10^{-2} \text{ m/km}$ )

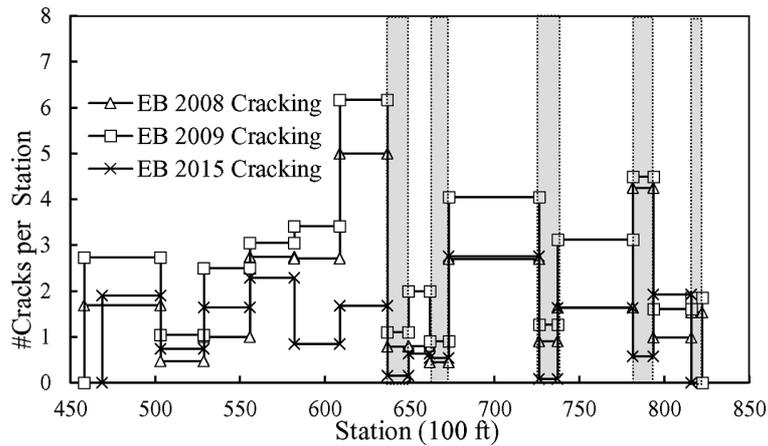
The number of transverse cracks along the whole length of the UBCO section was counted from images collected with the profiler. The cracks per station were counted and plotted over the length of the project in Figure 4 (eastbound) and Figure 5 (westbound). Crack surveys conducted by ODOT in 2008 and 2009 were added to the plot. In the plots,

the shaded areas are locations of full-depth concrete reconstruction (Portland cement concrete (PCC) thickness = 13 in or 330 mm). From the graph, it can be seen the number of cracks per station increased from 2008 to 2009. In 2015, number of cracks decreased, because some of the slabs were repaired during the interim. Comparing the two directions, the eastbound direction experienced much more cracking than the westbound direction. Comparing the UBCO with the full-depth repairs the UBCO portions have many more cracks.

**Figure 4** Eastbound cracking plot (100 ft = 30.5 m)

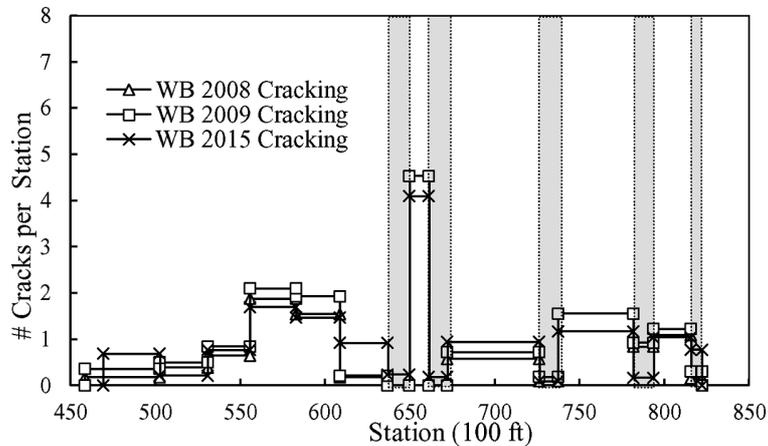
**Figure 5** Westbound cracking plot (100 ft = 30.5 m)

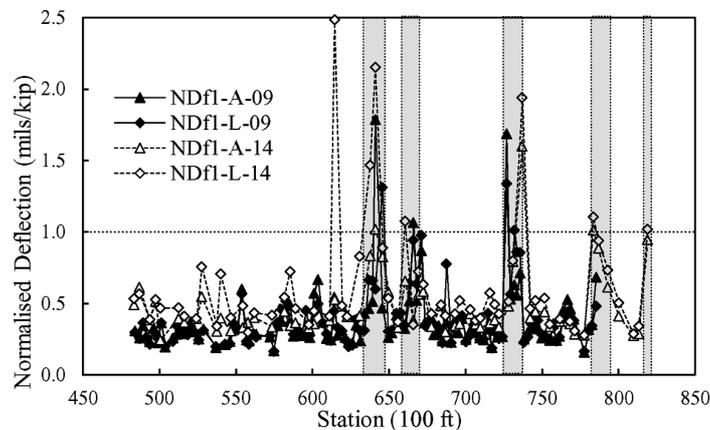
- Full-depth sections (shaded in the graphs) have higher joint deflections than UBCO sections. This can be explained by the fact that UBCO has old concrete pavement as a base, which is much stiffer than aggregate base in the full-depth repairs.
- Comparing eastbound direction with westbound direction, eastbound direction has higher and more variable joint deflections. LTE of eastbound direction is lower and more variable than westbound direction. Comparing data of 2014 with those of 2009, joint deflections increased by a small percentage while LTE dropped significantly from 2009. Note the joints tested in 2014 were not necessarily the same ones tested in 2009, however.

**Figure 6** MAD-70 eastbound normalised joint deflections (1 mil/kip = 5.71 mm/MN, 100 ft = 30.5 m)

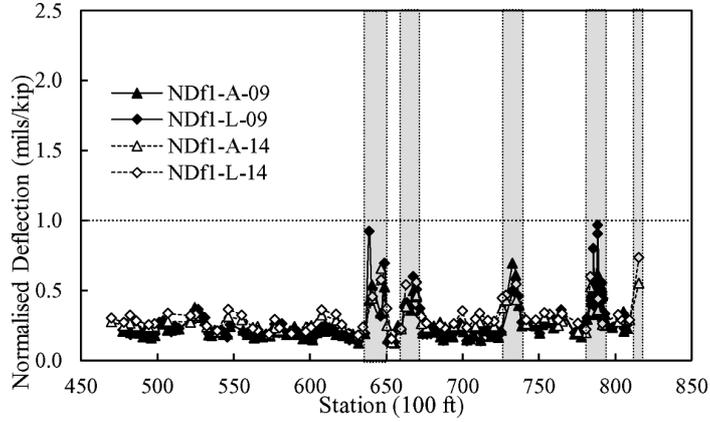
**Figure 7** MAD-70 westbound normalised joint deflections (1 mil/kip = 5.71 mm/MN, 100 ft = 30.5 m)

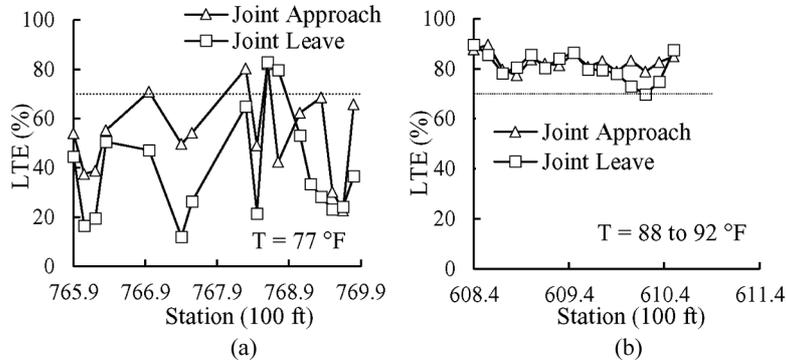
Figure 10 shows the LTE results of selected test sections. LTE is generally poor on the distressed section. Most joints have LTE less than 70% and greater variation joint to joint; in some joints the LTE less than 20%. This indicates the dowels are ineffective. The control joints showed satisfactory LTE; only one joint had LTE at 70% or less. The temperatures during testing are 77°F (25°C) in distressed section (EB) and 88°F (31°C) in control section (WB), which are relatively high and slab expansion would have tended to lead to joint interlock, which would improve LTE, thus the joints with low LTE would be expected to have even lower LTE at lower temperatures.

**Figure 10** (a) Distressed section (EB) LTE and (b) control section (WB) LTE (100 ft = 30.5 m) (T = pavement surface temperature)

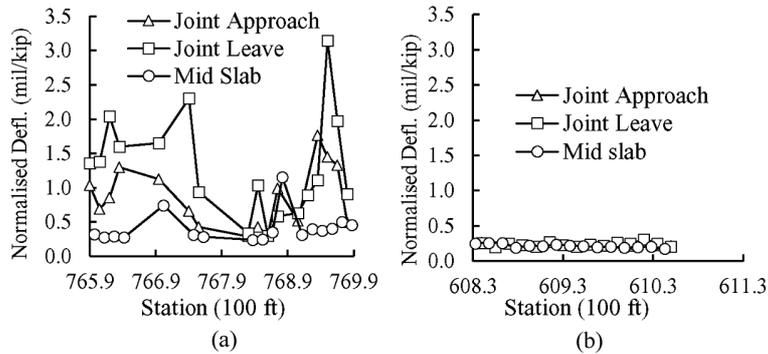
Figure 11 shows the normalised deflection results of the selected sections. The distressed section showed high normalised joint deflections, as great as 3.7 mil/kip (21 mm/MN), with high variation from joint to joint. Deflections on the joint leave position are relatively higher than the joint approach position. The control section showed small and uniform normalised joint deflections, most below 0.25 mil/kip (1.43 mm/MN).

**Figure 11** (a) Distressed section (EB) normalised deflections and (b) control section (WB) normalised deflections (1 mil/kip = 5.71 mm/MN, 100 ft = 30.5 m)

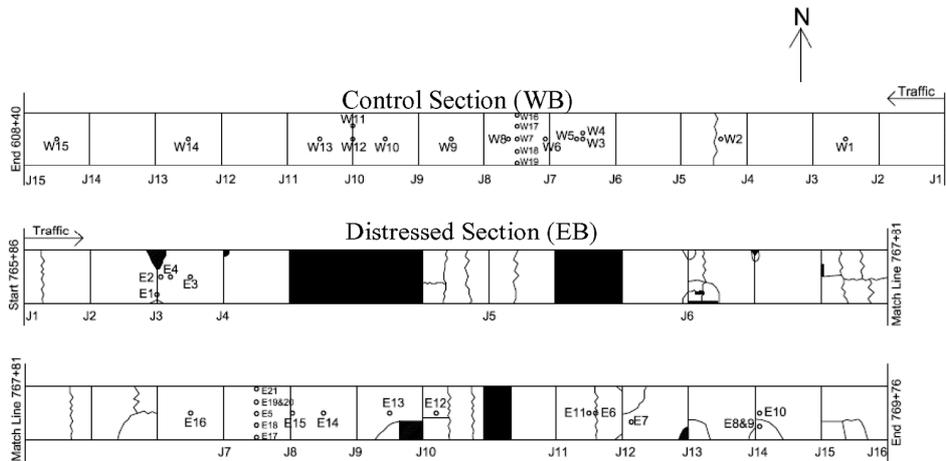
During coring, water drained very slowly from the core holes on both sections, indicating a lack of drainage for water entering the pavement through the joints. It is possible this water saturated the asphalt bondbreaker near joints and cracks.

In the distressed section (EB), bondbreaker was soft or missing in areas with angled cracks and corner breaks. Seven of the 19 core holes on the distressed section have no bondbreaker material or only deteriorated pieces. Five of these core holes are located next to or near the joints. Tenting was found in a failed joint and was beginning in a joint that looked good from the surface. A core hole adjacent to a corner break revealed a small gap between the bondbreaker and the overlay slab.

In the control section (WB), bondbreaker was found in all core holes, including those at joints, and at an average thickness of 1.9 in (48 mm), 46% thicker than in the eastbound direction, which averaged 1.3 in (33 mm). Only one joint had bondbreaker that was damaged but in the hole the bondbreaker felt solid. Only two joints out of 15 showed any signs of distress. The worst one was cored. The core collected in the wheel path fell apart. A core on the transverse joint broke and showed signs of tenting. A core was collected at a small crack which verified the presence of top down cracking.

**Figure 12** Distress map and coring plan on MAD-70 (numbered joints were scanned by MIT Scanner)
