Investigation of the structural behaviour of a masonry castle by considering the actual damage

Abstract: The structural behaviour of Frangokastello, a mediaeval masonry castle located in Crete, Greece is studied. The structure presents several damaged areas, consisting of cracks and local failure of masonry. The finite element method (FEM) is used to investigate how the existing failure of the structure affects its mechanical response. First, an eigenvalue analysis of the structure without the cracks and a dynamic modal analysis are done. Then, a non-linear constitutive model using a smear crack law is used to investigate the limit state of the structure under static and dynamic loading. Finally, unilateral contact interfaces are introduced, to simulate the cracks which appear in the

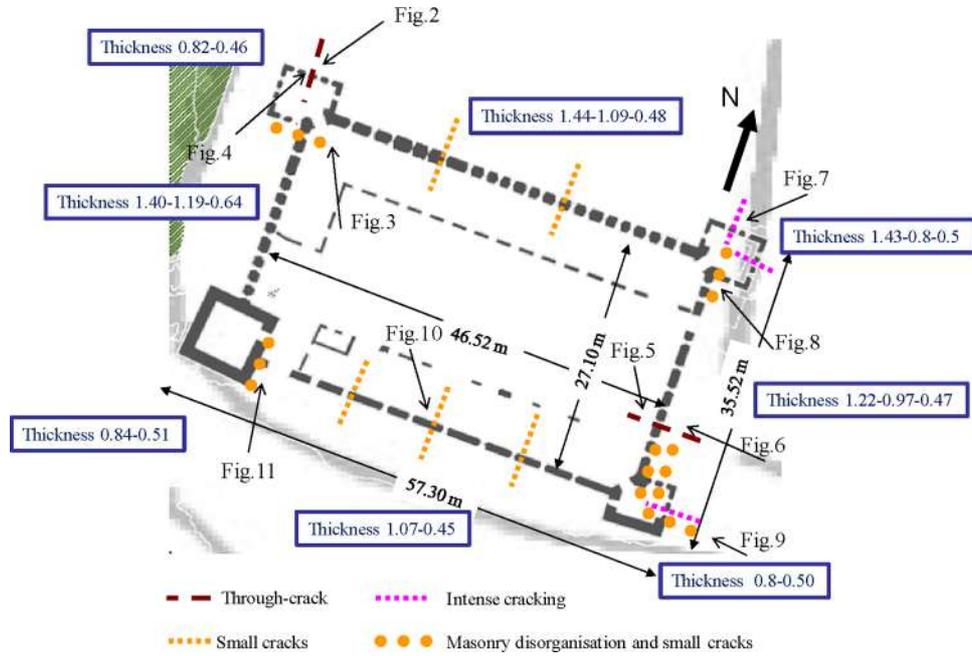
The Frangokastello castle consists of three small towers and a third bigger with height equal to 9 m and 15 m accordingly and four perimeter walls. A plan view of the castle follows, which indicates the main dimensions and the position of the damages (Figure 1).

Figure 1 Plan view of the carrier and major structural damages (see online version for colours)

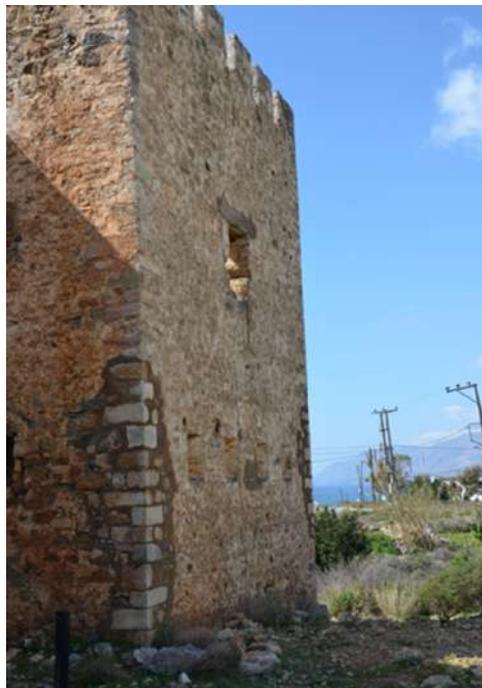
The major damage is located on the Northwestern tower, and is visible with a vertical crack which runs the north side and creates an opening of a few centimetres. The crack appears along the entire height of the tower (Figures 2–4). It is a bending tensile crack, out of plane bending of the wall, in combination with the tower turning as shown at the results of the analysis.

Figure 2 North West tower: east side (see online version for colours)

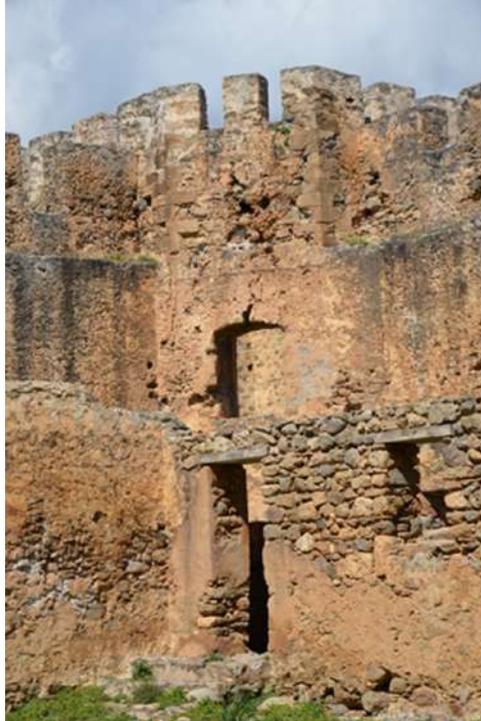
Figure 3 North West tower: entrance (see online version for colours)

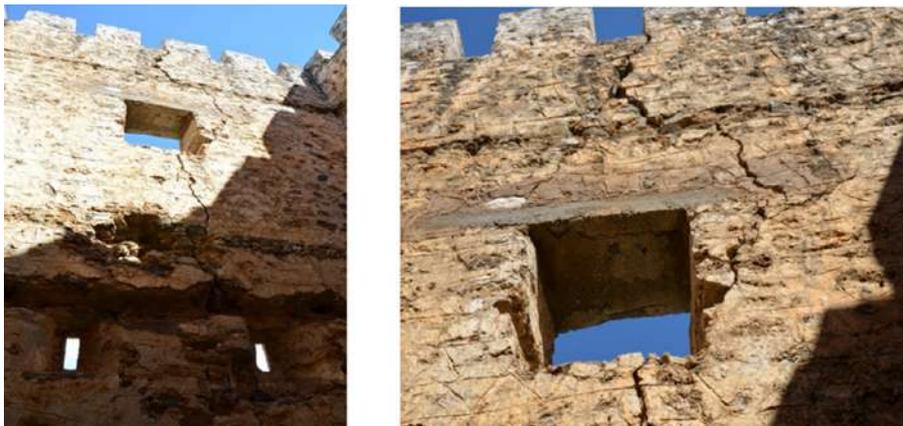
Figure 4 Large bright, vertical crack in the north facade, of the NW tower (internal view) (see online version for colours)

- 1 The large, bright, vertical crack in the entire height of the north face of the northwest tower is a risk factor for the tower. In likely seismic phenomenon could lead to collapse to part of the tower.
- 2 The northwest tower vibrates at the first frequencies of the structure as shown by the modal analysis. This compared with the previous conclusion lead to the need of strengthen measures which should be taken this tower.
- 3 The disorganisation of the wall in the centre of the south wall appears to be due to out of plane bending after seismic phenomenon. This failure mode is confirmed by the non-linear analysis, under actual earthquakes. In parallel, the south wall is vibrated at the first frequency as shown by the modal analysis.

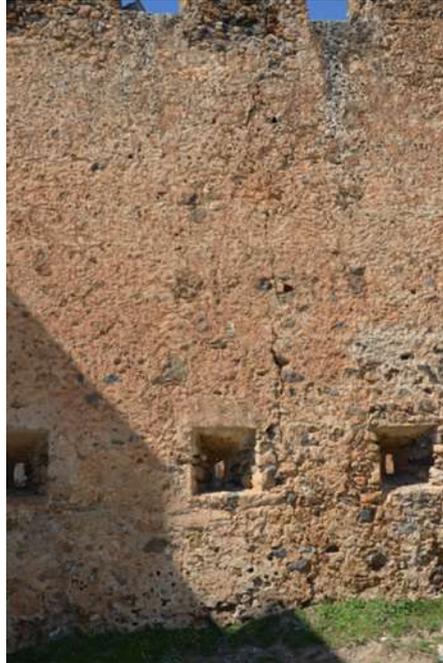
Another, through crack with smaller opening appears along the entire height of the east wall of the structural core (Figures 5 and 6). This crack is also due to out of plane bending of the wall of free height of ~8 m and 1.25 m average thickness. Notably the corresponding, western, perimetric wall of the fortress, of shorter length and larger average thickness (1.4 m) does not display similar failure.

Figure 5 Vertical, through and through crack in the east wall: external view (see online version for colours)

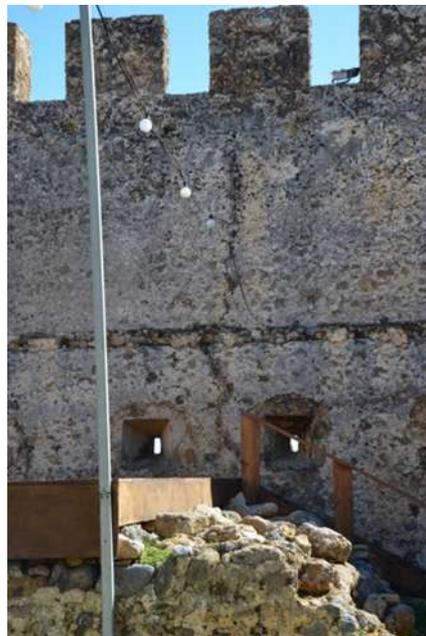
Figure 6 Vertical, through and through crack in the east wall: internal view (see online version for colours)

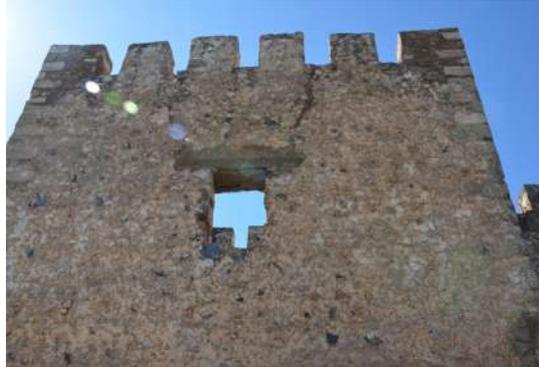
On the north side of the north east tower (Figure 7), another crack appears (partially refurbished), where we can observe the phenomenon of the disruption of the masonry (Figures 8).

Figure 7 Crack in the north face, north east tower (see online version for colours)

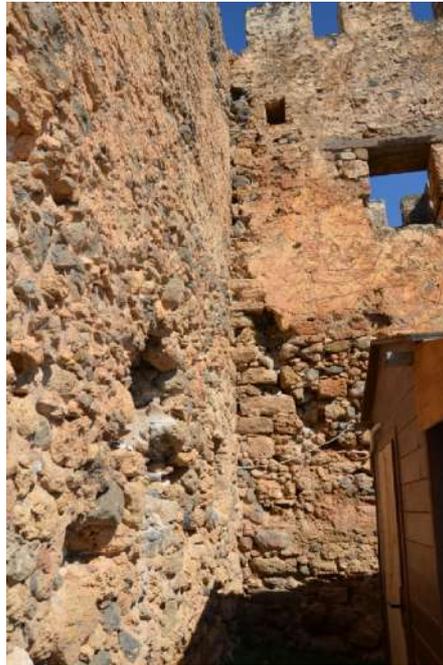
Figure 8 Disruption of the masonry in the south side, north east tower (see online version for colours)

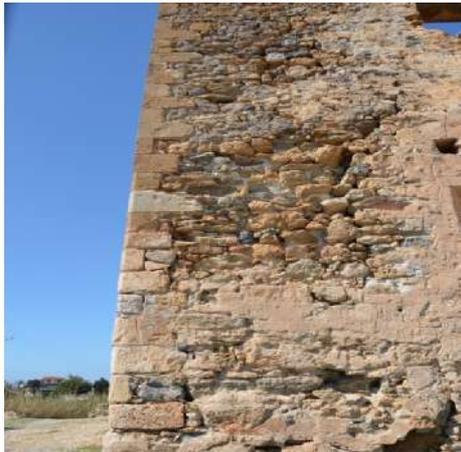
We can observe similar behaviour to the southeast tower, with cracks on the east side (Figure 9) and disruption of the masonry at lower levels. The cracks in this specific region are due to the out of plane bending of the masonry and shear failure, which begins from the opening and appears at the region, where we have reduction of the cross-section (see, architectural plans, where the south wall's thickness is 1.4 m and the east and north wall's is 0.77 m).

Figure 9 Cracking and disruption of the masonry, in the east side, south east tower (see online version for colours)

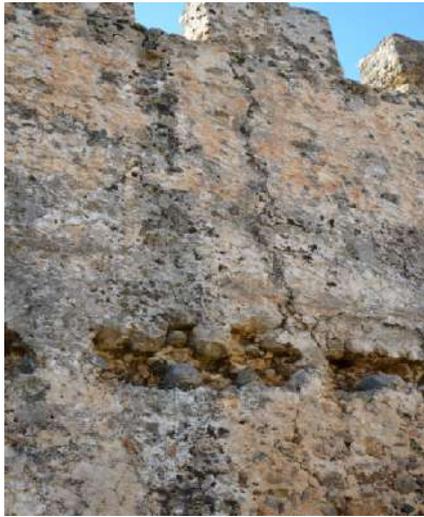
Smaller cracks appear on the south wall (Figure 10), due to out of plane bending (according to the analysis). At the same time, lower on the south wall and at the area which is connected to the tower (Figure 11), we can detect strong disruption of the masonry.

Figure 10 Disruption on the top of a south wall, internal view (see online version for colours)

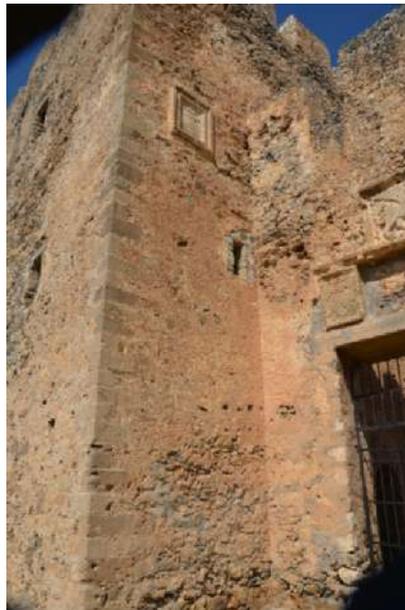
Figure 11 Disruption of the masonry, in the connection area between the south wall and the south west tower (see online version for colours)

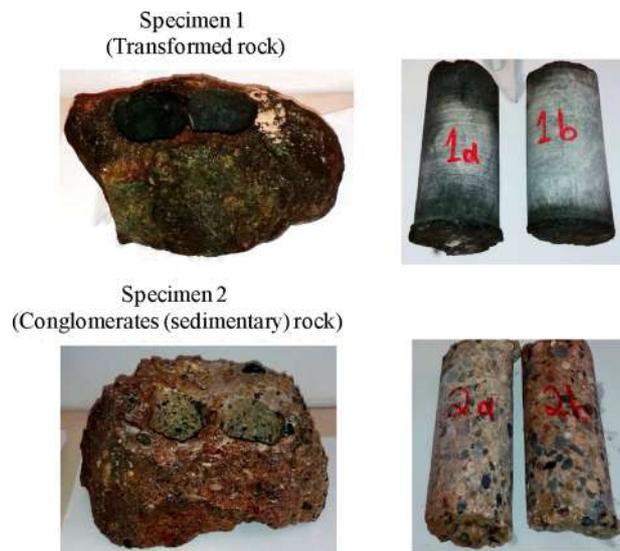
Figure 12 Two of the stone samples from which the specimens were extracted (see online version for colours)

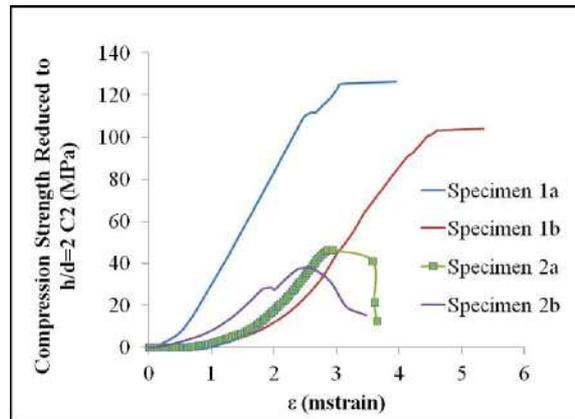
To investigate the non-linear behaviour of the core, compression tests were conducted again, on samples of stones. Figure 13 shows the stress-strain diagrams of uni-axial compression, of different components.

Figure 13 Stress-strain diagrams of uni-axial compression, of different components (see online version for colours)

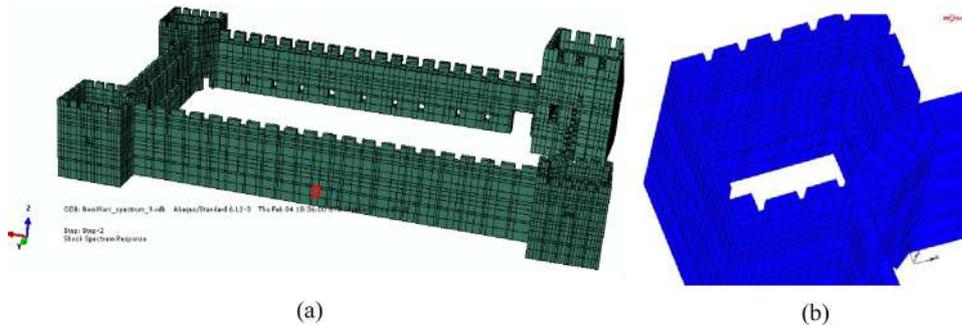
Figure 14 (a) The mesh of finite elements (Model 1) and (b) detail of finite element mesh across the wall thickness (see online version for colours)

Model 1: The state of the body, before the failures, assuming an average quality of material around the structure (M1 from Table 3) as shown in Figure 14.

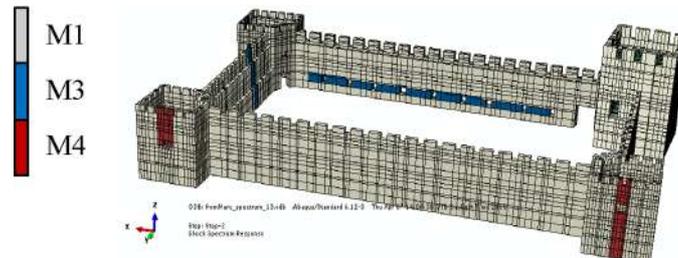
Model 2: The present condition of the structure considering the extensive cracking areas and faults material with much lower modulus of elasticity and strength (Figure 15). Specifically for the region of large fracture (north side) of the North-Western tower and the smallest crack (north side) of north-eastern tower the modulus of elasticity was considered equal to 10 GPa (M4). For the remaining cracks and areas of intense disorganisation of the masonry, modulus equal to 14.63 GPa (M3) was considered.

Figure 15 Finite element mesh with different material to areas with extensive cracks (red for M4) and intense disorganisation of the masonry (blue for M3), (Model 2) (see online version for colours)

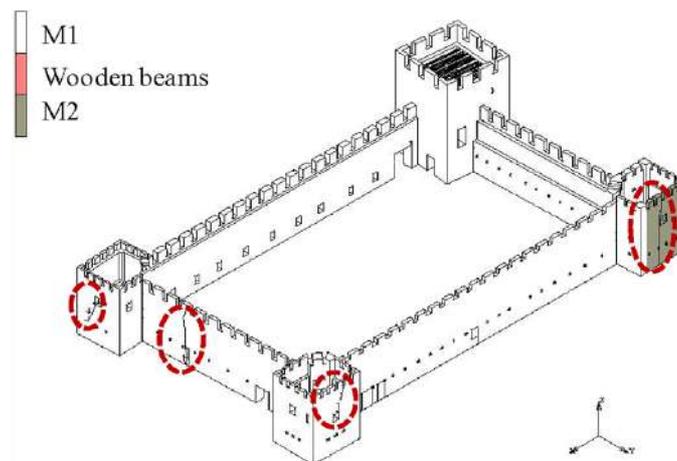
Model 3: The present condition of the structure considering the main cracks of the structure which were modelled by unilateral contact along interfaces where separation and frictional effects are considered (see Section 3.3). Average quality of material around the structure, (M1) was assumed and for the region of large fracture (north side) of the north-western tower, material with much lower modulus of elasticity and strength (M2) was considered (Figure 16).

Figure 16 Finite element model with different material to the area with extensive crack (grey for M2) and considering the main cracks of the masonry (red lines), (Model 3) (see online version for colours)

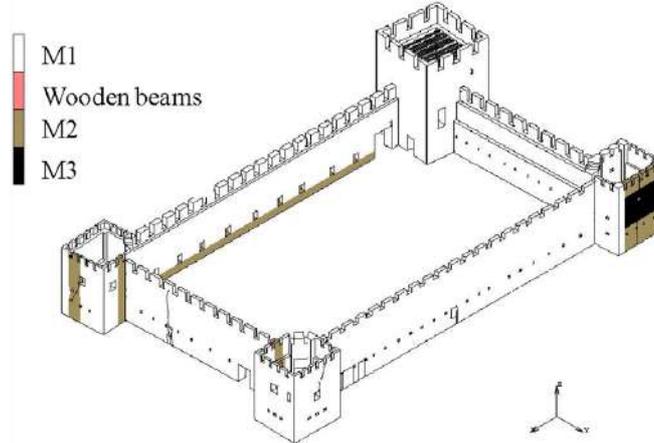
Models 4, 5, 6: The present condition of the structure considering the extensive cracks of the structure (as Model 3). Average quality of material around the structure, (M1) was assumed and for the regions of the large fracture (north side) of the north-western tower, the south wall, the east and north wall of the South-East tower and the north wall of the north eastern tower, material with much lower modulus of elasticity and strength (M2) was considered. Additional lower quality of material was used (M3) for a specific area around the large fracture (north side) of the north-western tower with intense disorganisation of the masonry (Figure 17). Different parameters of friction were assumed for the three models 4, 5 and 6 (Table 4).

Figure 17 Finite element model with different materials to the area with intense disorganisation of the masonry (grey for M2 and black for M3) and considering the main cracks of the masonry (Models 4, 5 and 6) (see online version for colours)

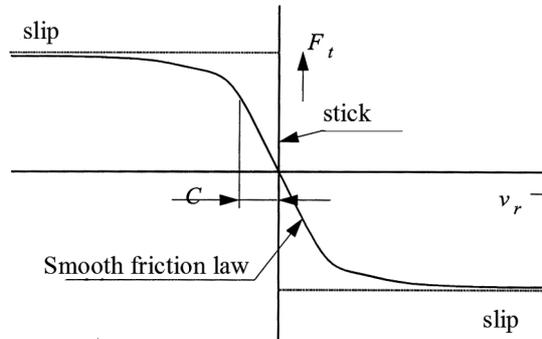
where v_r is the relative sliding velocity and C is the relative sliding velocity below which sticking is simulated. The relative sliding velocity is a constant used to smoothen the transition between the stick and no-stick conditions. The slip force is a function of the relative velocity and the input constant. The larger the value, the smaller the force required to generate slip.

Figure 18 Coulomb friction model including relative sliding

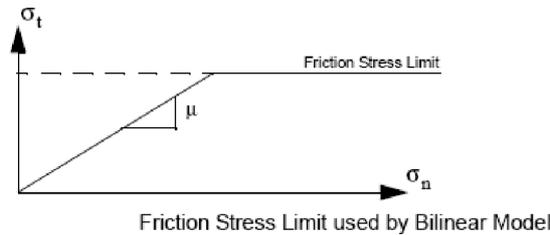
Figure 19 Friction stress limit used by bilinear model from the MARC theoretical manual

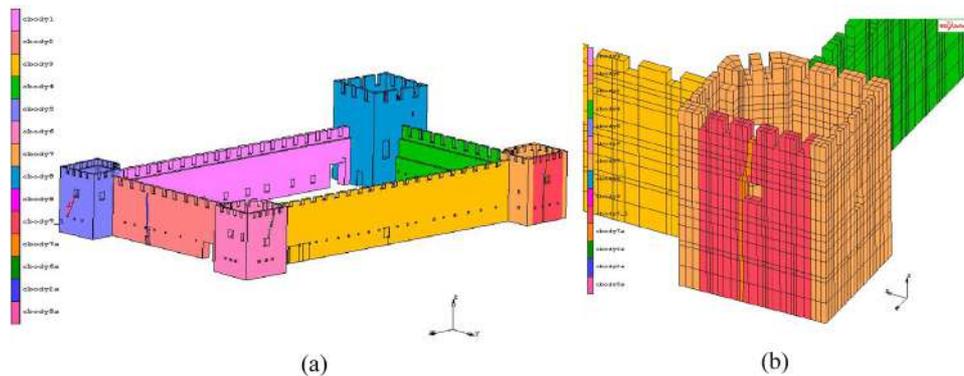
Figure 20 (a) Contact bodies from which the finite element model consist and (b) modelling of major crack of NW tower (see online version for colours)

Between the flexible contact bodies which represent the different parts of the structure (perimeters walls, towers, see Figure 20(a)) fixed conditions were considered. The consideration that not unilateral contact phenomena between walls and towers will be developed based on the absence of significant cracks at the connections to the structure. The technique of flexible contact bodies was used to describe the cracks (like the major crack at the NW tower which is shown in Figure 20(b)) assuming that across these interfaces separation and friction effects are considered.

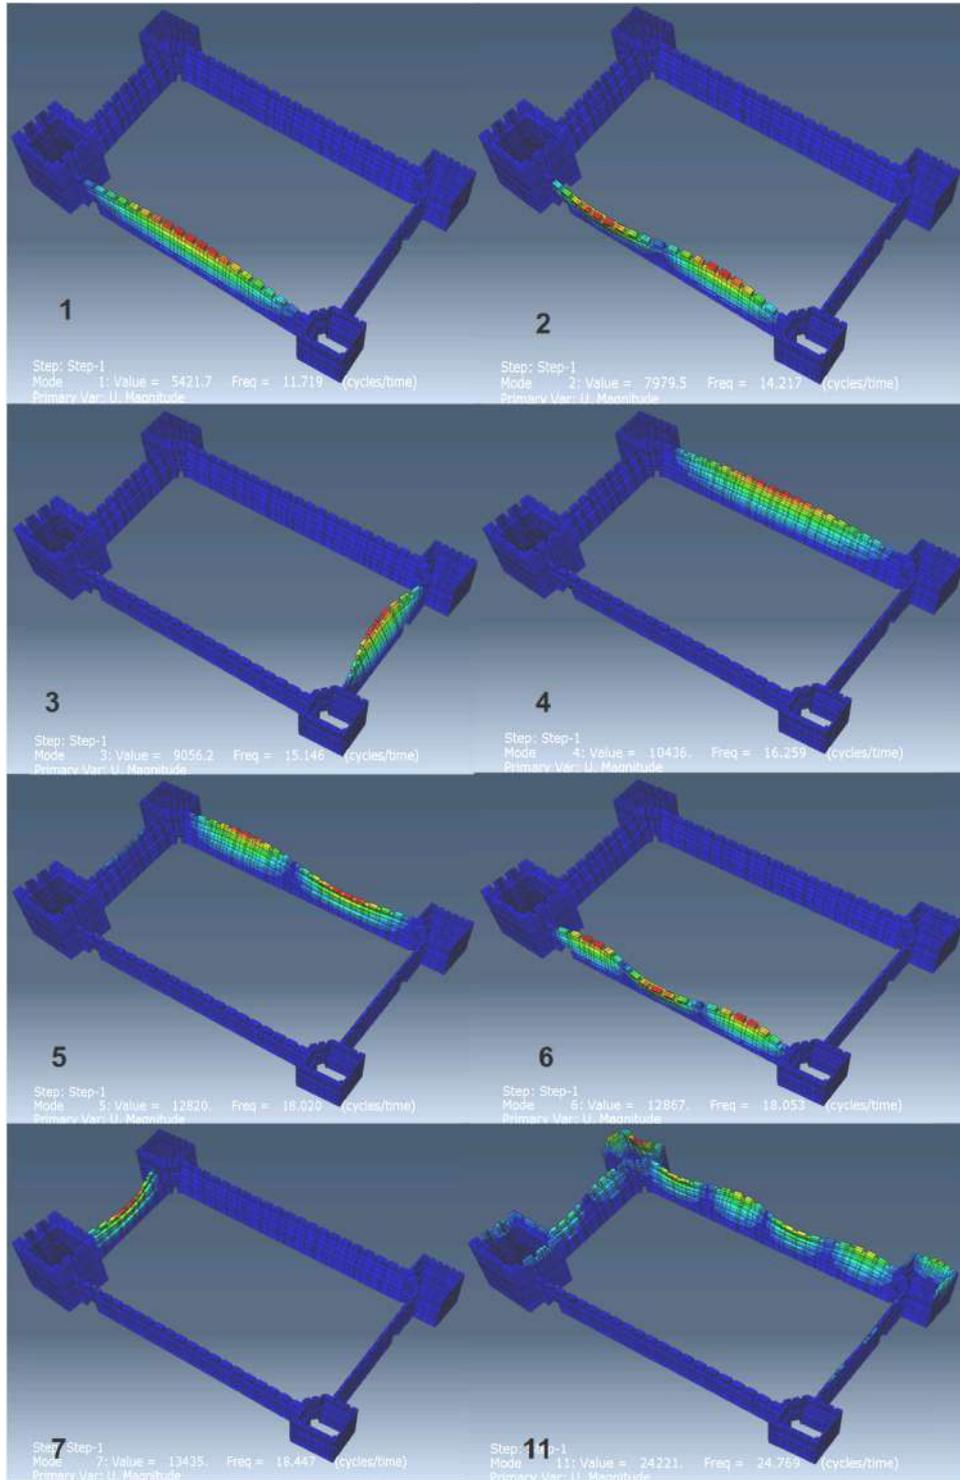
Figure 21 The first seven and the 11th normal modes (see online version for colours)

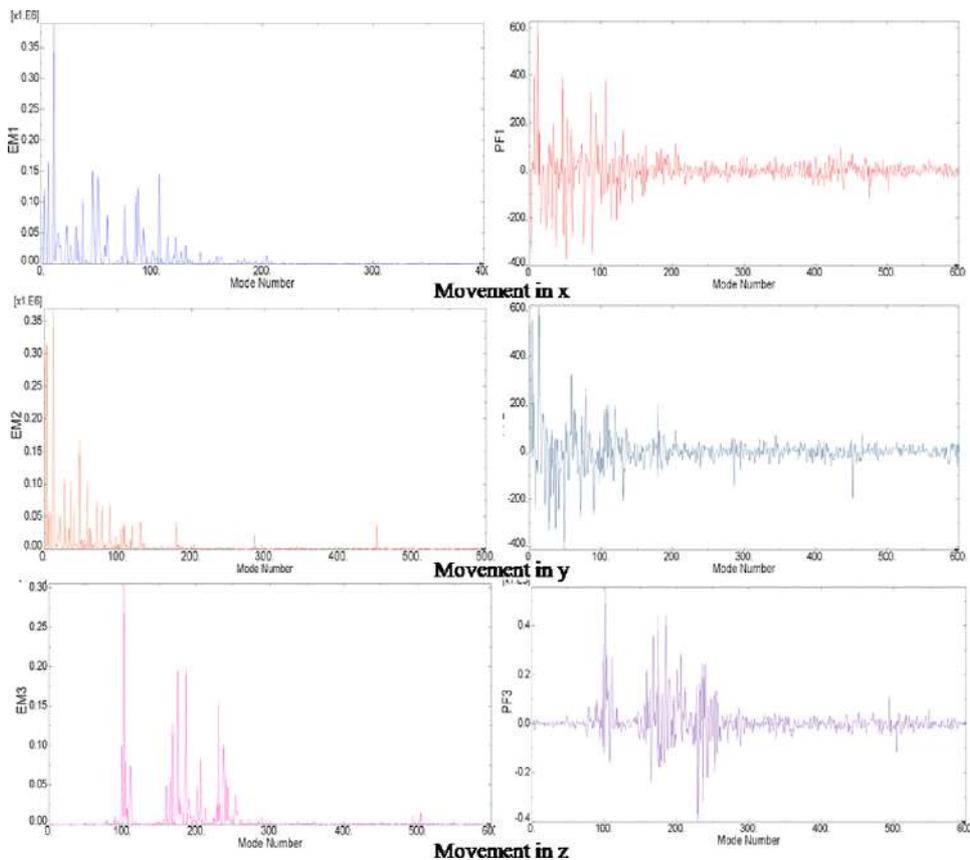
Figure 22 The effective modal mass (EM) and the participation factor (PF) in movement about the $x/y/z$ axis (see online version for colours)

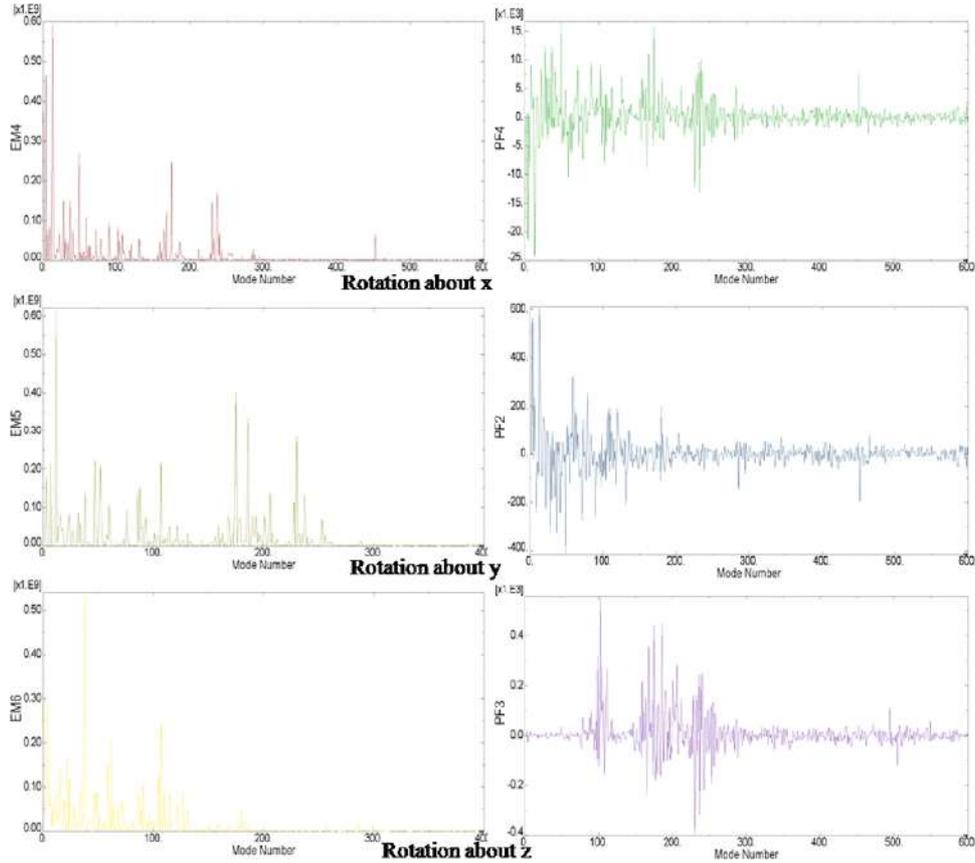
Figure 23 The effective modal mass (EM) and the participation factor (PF) in rotation about the $x/y/z$ axis (see online version for colours)

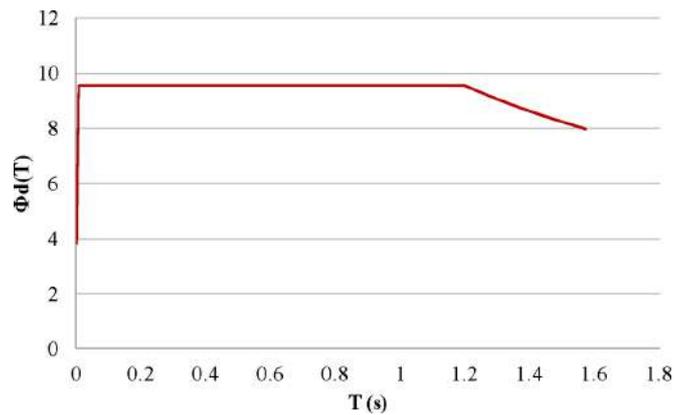
Figure 24 The design spectrum (see online version for colours)

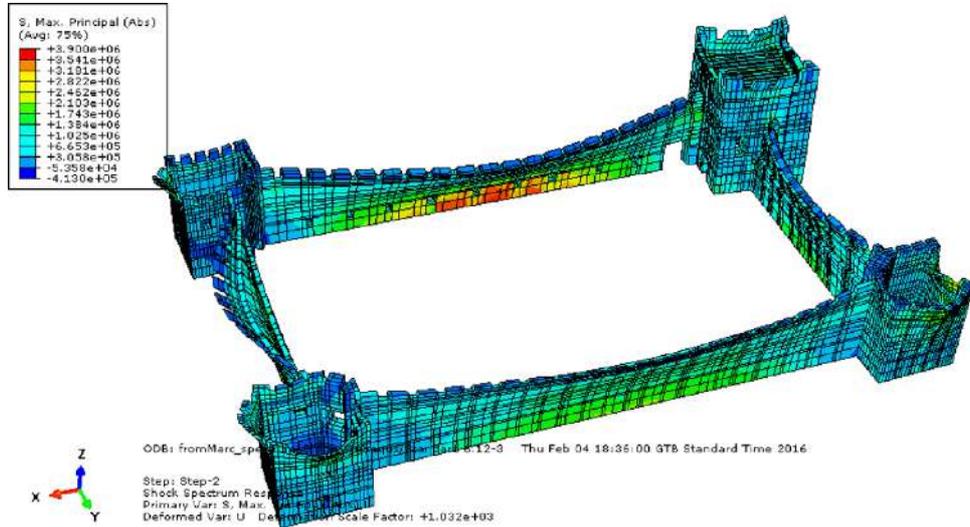
Figure 25 Maximum principal stressed (Pa) at the end of spectral analysis (northeast view) – Model 1 (see online version for colours)

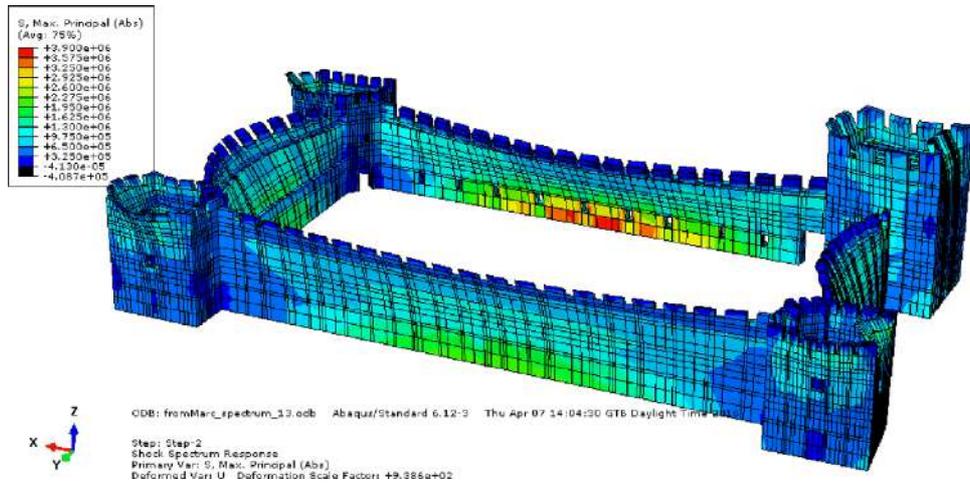
Figure 26 Maximum principal stressed (Pa) at the end of spectral analysis (northwest view) – Model 2 (see online version for colours)

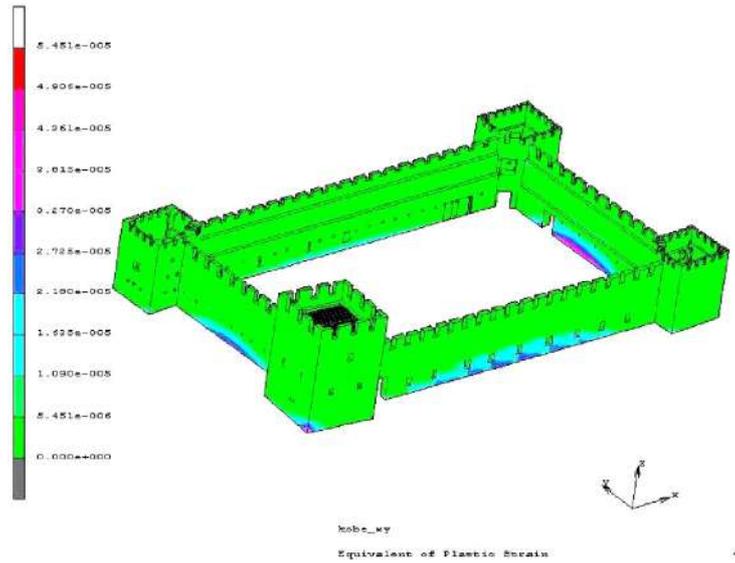
Figure 27 Contour plot of equivalent plastic strains of Model 1 and earthquake Kobe_xy (see online version for colours)

In the case with the elastoplastic material model, the estimation of the region with plastic strain is an indication of failure and crack development. In Figures 27 and 28, the contour plots of equivalent plastic strains are shown. The main cracks and the activation of unilateral contact between parts of the cracks lead to increase of plastic strains at the base of south wall, the place where serious faults exist.

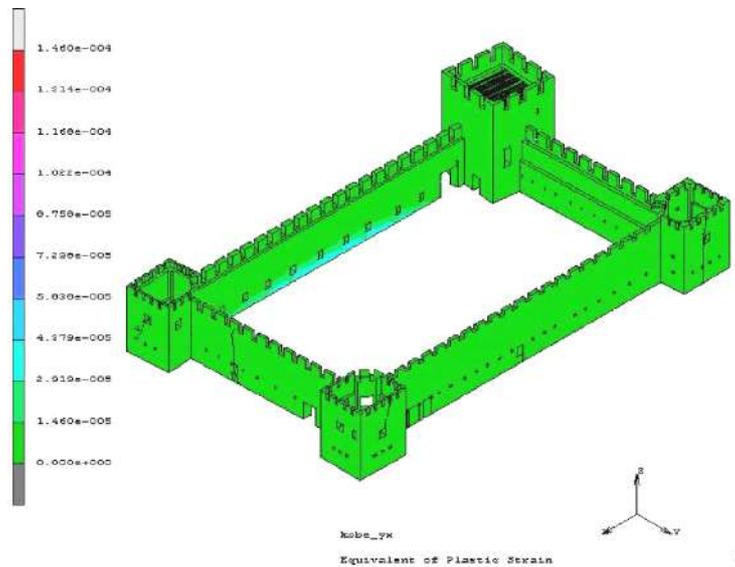
Figure 28 Contour plot of equivalent plastic strains of Model 4 and earthquake Kobe_yx (see online version for colours)

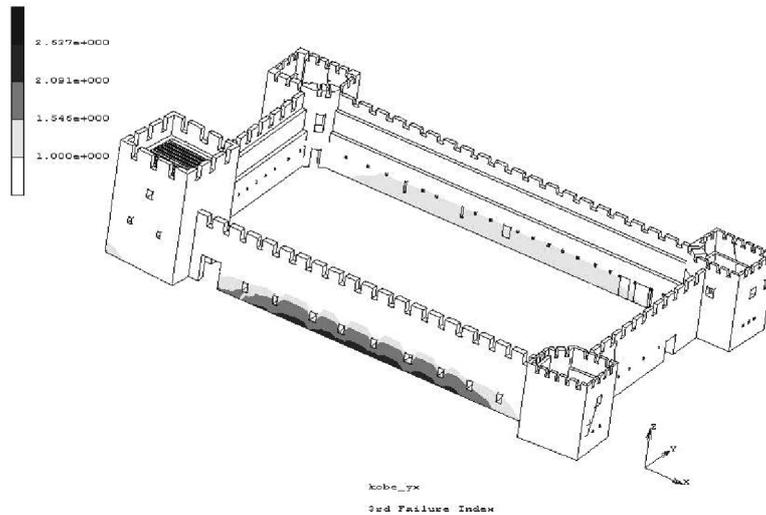
Figure 29 Contour plot of 3rd failure index (maximum 2.627) of Model 4 and earthquake Kobe_yx (time step 11.5)

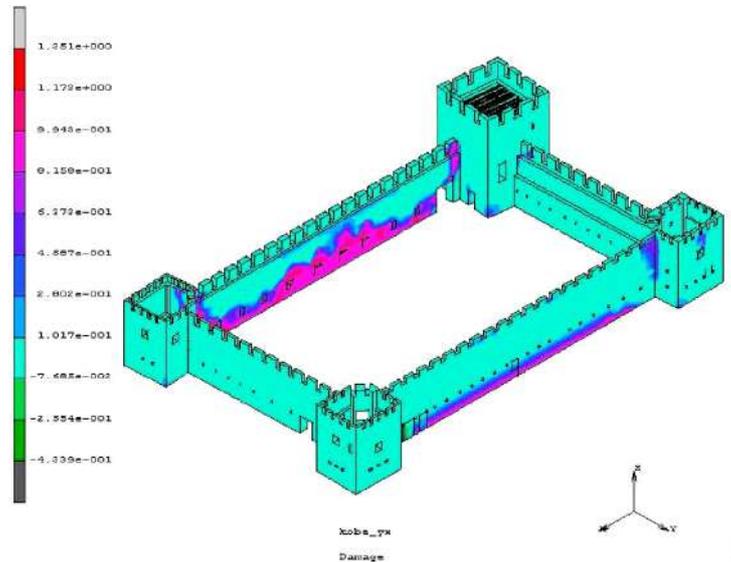
Figure 30 Contour plot of damage index (maximum 1.351) of Model 1 and earthquake Kobe_yx at final time step (see online version for colours)

the same earthquake with an intensity of 60% of the initial are applied (Kobe_yx). From the results of the analysis it was shown that the more critical was the second case (Figure 30). The first case was critical to the vibration of the north wall of the north-west tower. The activation of cracks, at the first time steps of the analysis, acts as mechanism of energy dissipation leading to reduction of the vibration to the structure (Figure 33). When cracks open and no friction mechanism exists the mechanism of energy leads to appearance of more cracks and faults of the structure at different places (Figures 31, 32, 34 and 35). The same conclusion was extracted from Figure 33 where the out of plane displacement of the top line of southern wall ($Uy(m)$) for the first case (earthquake Kobe_xy) is shown.

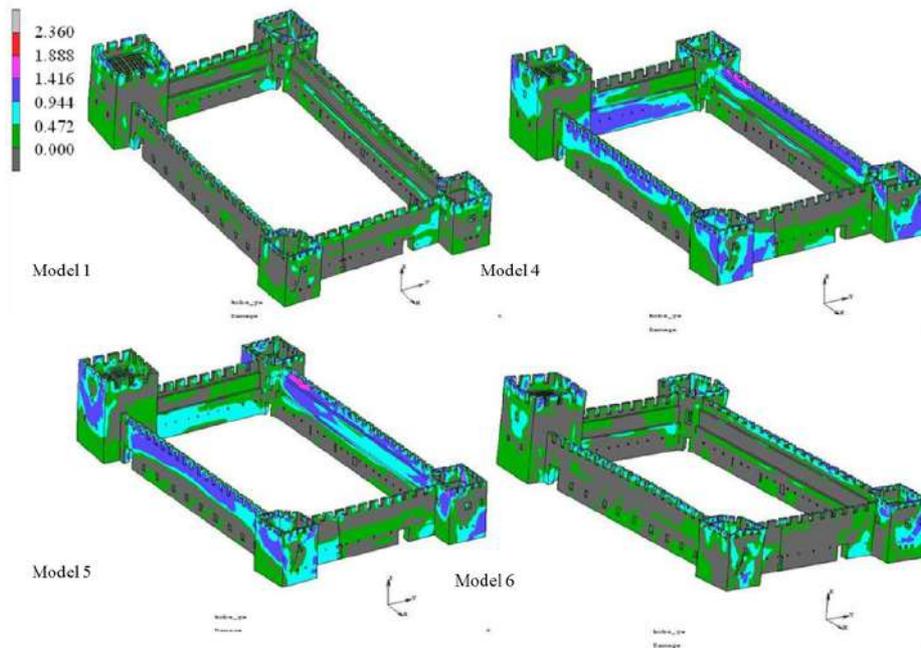
Figure 32 Contour plot of damage index of Models 1, 4-6 and earthquake Kobe_yx at time step 11.5 s (see online version for colours)

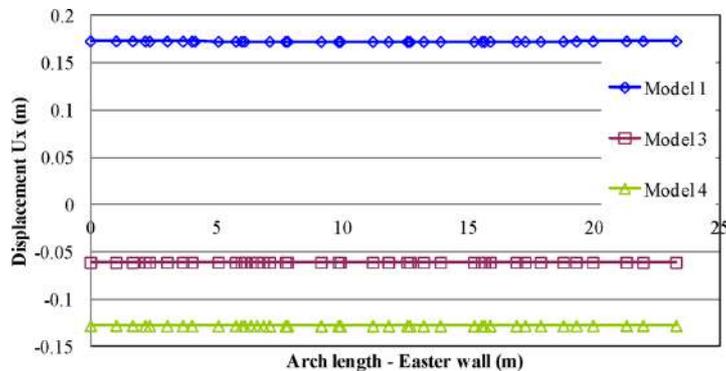
Figure 33 Out of plane displacement ($Ux(m)$) across the top of eastern wall and earthquake Kobe_xy (see online version for colours)

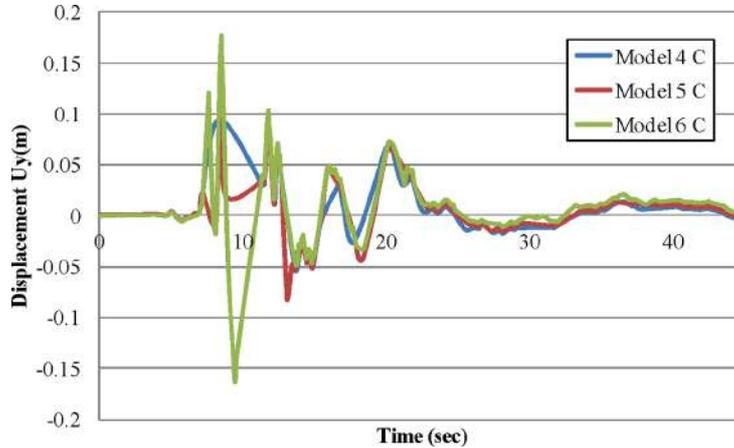
Figure 34 History of the out of plane displacement (U_y (m)) at point C (middle of the top of the north wall of the northwest tower) and earthquake Kobe_yx (see online version for colours)

The history of the out of plane displacement for two points, C (middle of the top of the north wall of the northwest tower) and E (middle of the top of the north wall of the north-eastern tower) are given in Figures 34 and 35, for the second case of base excitation (Kobe_yx). The activation of cracks as it was modelled by the unilateral contact interfaces, leads to variation of the structural vibration. If the existing cracks remain without any strengthening, after the excitation of new earthquakes, new cracks will be developed which in combination with the old ones would lead to destroy of the structure.

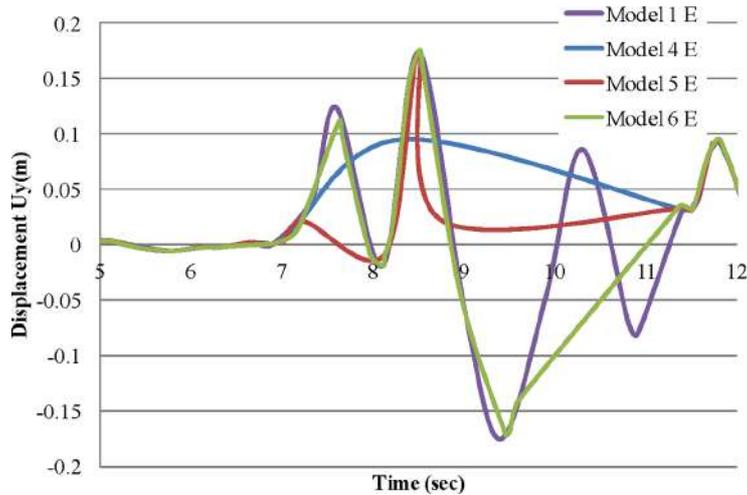
Figure 35 History of the out of plane displacement (U_y (m)) at point E (middle of the top of the north wall of the north-eastern tower) and earthquake Kobe_yx (see online version for colours)

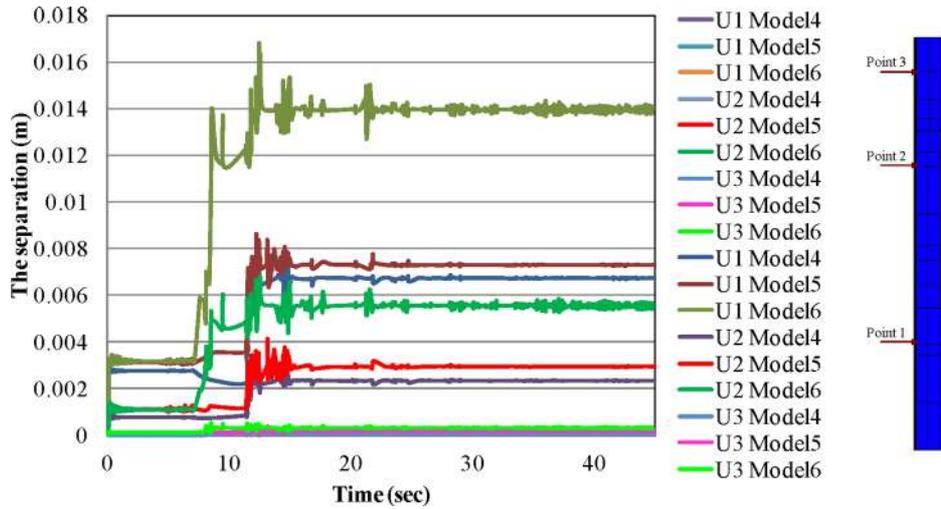
The mechanism of crack opening and closing is shown in Figure 36 for three indicative points of the cross section of the main crack at the North West tower. Contact status is an indication of the condition between the two contact bodies where

Figure 36 History of separation at three indicative points of the cross section of the main crack at the North West tower (see online version for colours)

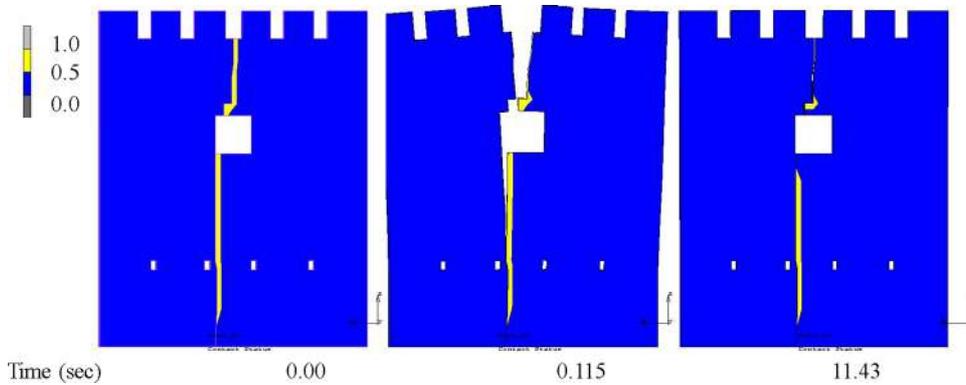
their interface represents the existing crack. When contact status is 0 means that two bodies are not in contact and when its value is 1.0 mean that two bodies are in contact (Figure 37).

Figure 37 Contact status at three time steps of the main crack at the North West tower (see online version for colours)
