**International Journal of Critical Infrastructures**

**Rehabilitation of pre-loaded reinforced concrete columns exposed to fire using advanced strengthening techniques**

# Rehabilitation of pre-loaded reinforced concrete columns exposed to fire using advanced strengthening techniques

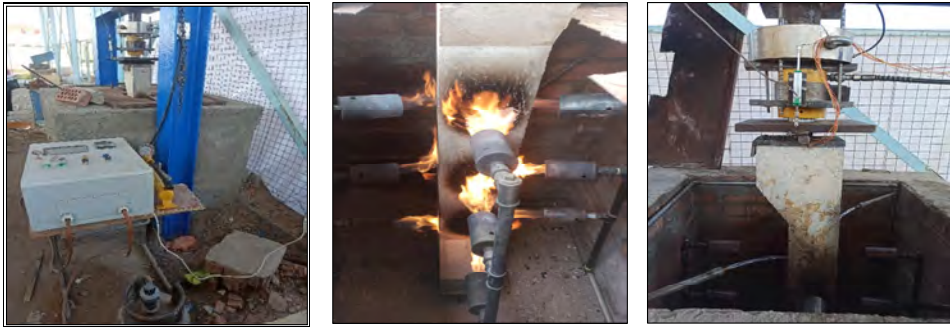
**Figure 4** Specimens subjected to fire exposure under pre-loading curve (see online version for colours)

Column  $C_1$  was not exposed to fire and served as the control specimen. In contrast, six columns were exposed to fire at the age of three months under two maximum temperature levels, namely 500°C and 700°C, for an exposure duration of 60 minutes after reaching the target temperature. Upon completion of heating, the flames were extinguished, the furnace enclosure was removed, and the cooling system specifically designed for this study was activated. The columns were then rapidly cooled by water spraying until reaching room temperature while maintaining the pre-applied load, in order to simulate realistic firefighting conditions in buildings. Comprehensive details of the furnace, testing setup, and preloading system are presented in Figure 4. During the fire tests, the heating regime was precisely controlled so that the average furnace temperature closely followed

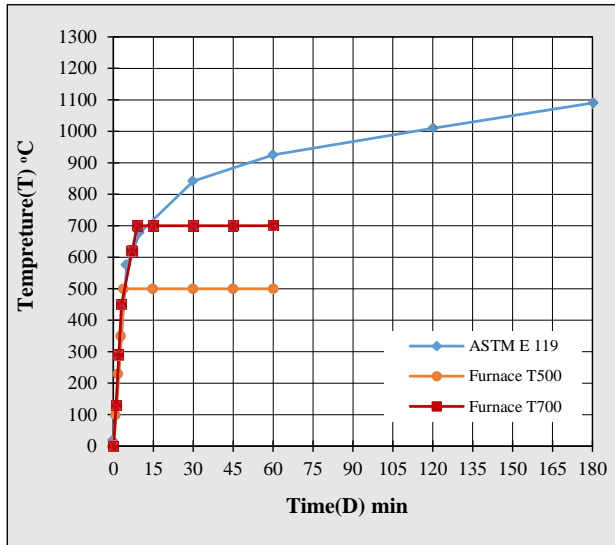
**Figure 5** Standard fire exposure according to ASTM E119-20 (see online version for colours)

the standard ASTM E119-20 time-temperature curve, as shown in Figure 5. Temperature distributions within specimens  $C_2 T_{500}W$  and  $C_5 T_{700}W$  were recorded using K-type thermocouples installed at a single cross-section located at mid-height of the column, as depicted in Figure 6. Four thermocouples were distributed across the section: one at the mid-depth of the concrete cover (T1), one attached to the longitudinal reinforcement (T2), one located at the mid-distance between the longitudinal reinforcement and the column core (T3), and one at the column core (T4). Temperature data were recorded using an eight-channel data acquisition system, and the resulting fire curves are presented in Figure 7.

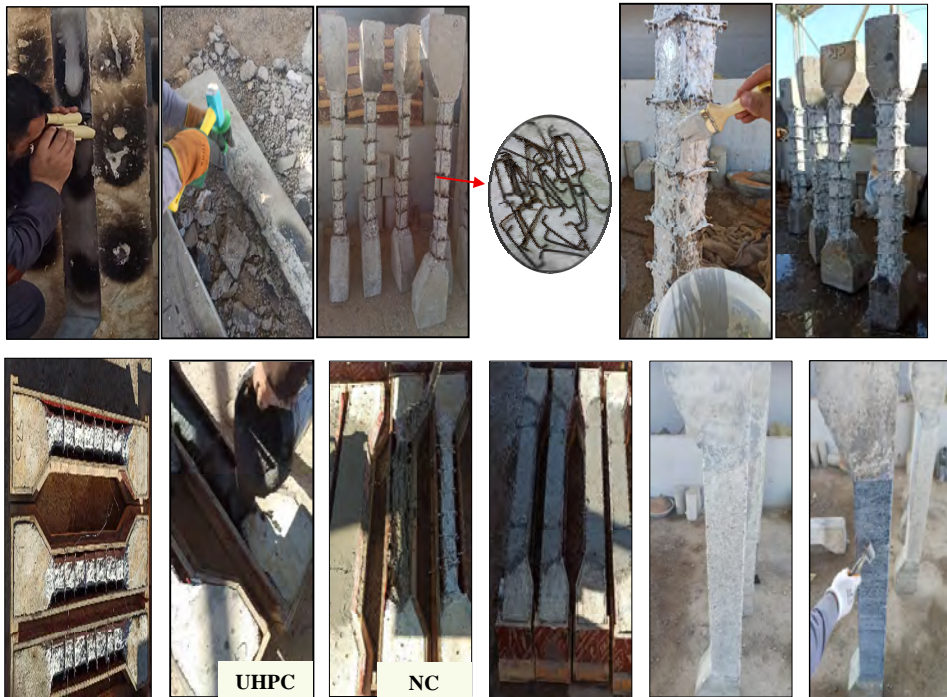
**Figure 8** Sequential steps of RC column repair (see online version for colours)

- a *Removal of damaged concrete:* the deteriorated outer concrete layer was carefully removed manually until the longitudinal reinforcement was fully exposed. Mechanical methods were avoided to prevent dynamic vibrations that could weaken the structural elements.

- b *Installation of shear connectors:* shear connectors with a diameter of 4 mm were horizontally welded on all four sides of the stirrups to ensure reliable bonding between the existing concrete core and the newly added outer concrete layer.

- c *Epoxy preparation and application:* the epoxy resin (Sikadur®-32 LP) was prepared by separately mixing the base and hardener, followed by thorough mixing using a low-speed drill for two minutes until a uniform colour was achieved, in accordance with the manufacturer's instructions. The cleaned surface of the existing concrete was then coated with a layer of epoxy to enhance the bond between the old and new concrete layers.

- d *Casting of new concrete:* two types of concrete were used for strengthening. Normal concrete was applied for the first strengthening stage ( $R_1$ ) with a compressive strength of 29.4 MPa, while UHPC was used for the second strengthening stage ( $R_2$ ). Both concrete types were water cured for 28 days. All procedures are illustrated in Figure 8.

- 1 *Cutting of CFRP sheets:* the CFRP sheets were cut to the required lengths, and the concrete surface was thoroughly cleaned to remove any contaminants.
- 2 *Epoxy preparation:* the two components of the epoxy adhesive (Sikadur-330, components A and B) were mixed at a ratio of 4:1 until a homogeneous colour was obtained.
- 3 *Epoxy application:* an epoxy layer with an approximate thickness of 1.5 mm was applied to both the column surface and the CFRP sheets.
- 4 *Installation of CFRP sheets:* a single layer of CFRP sheets were carefully placed onto the epoxy-coated column surface and pressed using a rubber roller to ensure full contact and to expel excess epoxy from both sides of the sheets. Any remaining epoxy at the sheet edges was removed, as shown in Figure 8.

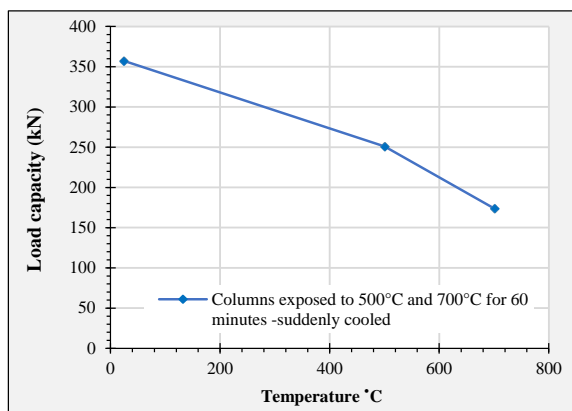
**Figure 10** Load capacity versus fire flame temperature (see online version for colours)

Compared with the unexposed reference column, the ultimate load-carrying capacity of columns C<sub>2</sub> T<sub>500</sub>W and C<sub>5</sub> T<sub>700</sub>W, which were exposed to fire at temperatures of 500°C and 700°C, decreased by 29.69% and 51.26% (respectively, as illustrated in Figure 10 and Table 4). Subsequently, the fire damaged columns C<sub>3</sub> T<sub>500</sub>WR<sub>1</sub> and C<sub>6</sub> T<sub>700</sub>WR<sub>1</sub> were rehabilitated using a full CFRP wrapping system. The results revealed that this strengthening technique did not fully restore the original capacity of the columns, as slight reductions of (4.48% and 10.36%), respectively, were still observed relative to the reference column. This reduction is attributed to the very low axial compressive stiffness of the CFRP sheets due to their small thickness compared with the concrete cross-section, which led to epoxy matrix rupture. Consequently, the primary load-carrying component within the composite layer was the unidirectional CFRP fibres, which inherently lack the

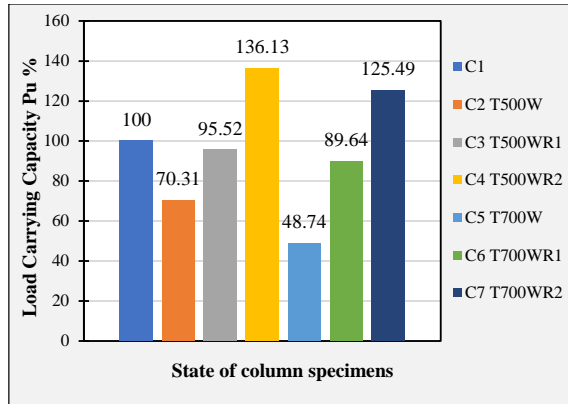
**Figure 11** Percentage of load carrying capacity for the tested column specimens (see online version for colours)

capacity to resist axial compressive forces, in agreement with the findings reported by Nicolae et al. (2008). Nevertheless, full CFRP confinement provided a notable improvement when compared with the corresponding fire-damaged columns, increasing the ultimate load capacity by (35.86% and 83.91%) relative to columns  $C_2 T_{500}W$  and  $C_5 T_{700}W$ , respectively.

Alternatively, UHPC was employed to strengthen and rehabilitate the fire-damaged columns  $C_4 T_{500}WR_2$  and  $C_7 T_{700}WR_2$  with the aim of enhancing and restoring their load-carrying capacity. During the rehabilitation process, UHPC completely reconstructed the deteriorated concrete cover. Compared with the unexposed reference specimen, this technique resulted in significant increases in ultimate load capacity of (36.13% and 25.49%), respectively. Furthermore, the strengthened specimens exhibited substantially higher improvements of (93.62% and 157.47%), respectively, when compared with their corresponding fire-damaged columns  $C_2 T_{500}W$  and  $C_5 T_{700}W$ , as illustrated in Figure 11. The superior enhancement in load-carrying capacity observed in severely fire damaged columns is mainly attributed to the mechanical degradation of the original concrete core. Thermal damage leads to a pronounced reduction in the stiffness and elastic modulus of the original concrete, causing a greater redistribution of stresses toward the high stiffness UHPC jacket. As a result, the UHPC layer carries a larger proportion of the applied load and provides effective confinement to the inner concrete core. In contrast, for columns subjected to moderate thermal damage, the contribution of UHPC to the overall structural performance is relatively limited, as a larger portion of the original concrete strength is retained, leading to lower enhancement ratios despite having the same jacket thickness.

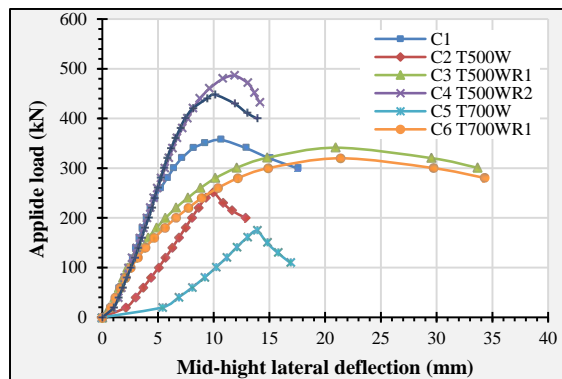
**Figure 12** Load-deflection of exposed and strengthened column (see online version for colours)

A clear convergence was observed between the lateral and axial displacement values, with both indicating an increase in ultimate displacement as the fire exposure temperature increased. Strengthening with CFRP contributed to an improvement in the displacement behaviour of the columns under loading. Figures 12 and 13 present selected load-displacement curves illustrating this response.

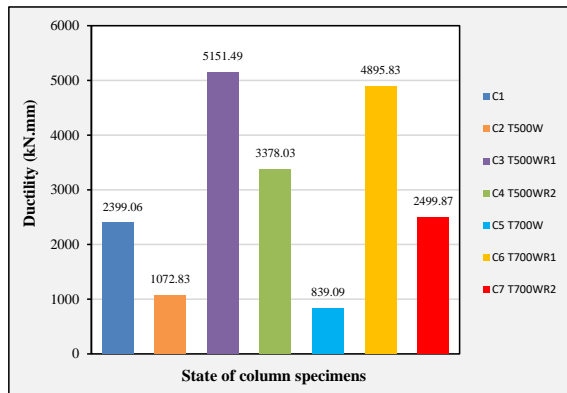
**Figure 16** The ductility of specimens (see online version for colours)

under the load displacement curve up to the maximum applied load. The calculated areas under the curves, which represent the ductility of the columns, are presented in Figure 16.

The results clearly demonstrate that strengthening with CFRP significantly enhances the ductility of fire exposed columns. Specifically, CFRP strengthening increased the ductility by 380.18 % and 483.47 % for columns exposed to fire temperatures of 500°C and 700°C, respectively. These findings highlight the effectiveness of CFRP in improving the post fire ductile behaviour of reinforced concrete columns by increasing their energy absorption capacity and enhancing resistance to sudden failure. These results are consistent with the findings reported by Toutanji (1999), who indicated that confining concrete with FRP sheets can substantially improve its strength, ductility, and energy absorption capacity. On the other hand, the obtained results also indicate that the ductility of fire exposed columns was markedly improved when strengthened with UHPC compared with the reference specimens. In particular, UHPC strengthening increased the ductility by 214.87 % and 197.93 % for columns exposed to fire temperatures of 500°C and 700°C, respectively. These results clearly confirm the efficiency of UHPC in enhancing the post fire ductile behaviour of reinforced concrete columns by increasing their capacity to absorb energy and improving their resistance to sudden failure.

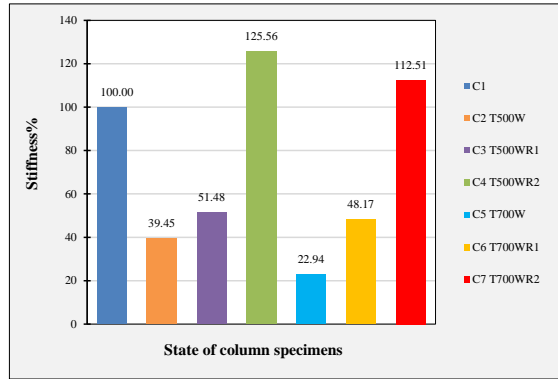
**Figure 17** Stiffness of specimens (see online version for colours)

The results clearly indicate that column stiffness decreases significantly with increasing fire exposure temperature and duration. At exposure temperatures of 500°C and 700°C, reductions in stiffness of 60.55% and 77.06%, respectively, were observed, accompanied by a corresponding decrease in load-carrying capacity. In contrast, strengthening with UHPC resulted in a substantial enhancement in both load-carrying capacity and column stiffness. Increases in stiffness of 218.24% and 390.42% were

recorded for columns exposed to 500°C and 700°C, respectively. Conversely, strengthening with CFRP led to comparatively smaller improvements in stiffness, amounting to 30.49% and 109.97% for columns exposed to 500°C and 700°C, respectively.
