## **Forensic study of premature failures with unbonded concrete overlay on interstate 70 in Ohio**

**Abstract:** This paper presents the results and findings from a forensic investigation initiated in 2014 to identify the causes of premature failures on an unbonded concrete overlay (UBCO) on Interstate 70 in Madison County, Ohio. This project was constructed in 1999 and 2000. Premature distress, including transverse cracking, corner breaks and slab settlement began to appear in 2008. Falling weight deflectometer (FWD) and distress survey data were collected from the field during the investigation. MIT Scan was used to evaluate dowel alignment. Concrete samples were taken from the field and tested in the laboratory. HIPERPAV was used to evaluate early behaviour of the Portland cement concrete (PCC). Results of finite element analysis was used to help understand the mechanisms responsible for the premature distresses.

**Reference** to this paper should be made as follows: Zhu, J., Sargand, S., Green, R. and Khoury, I. (2018) 'Forensic study of premature failures with unbonded concrete overlay on interstate 70 in Ohio', *Int. J. Forensic Engineering*, Vol. 4, No. 1, pp.1–19.

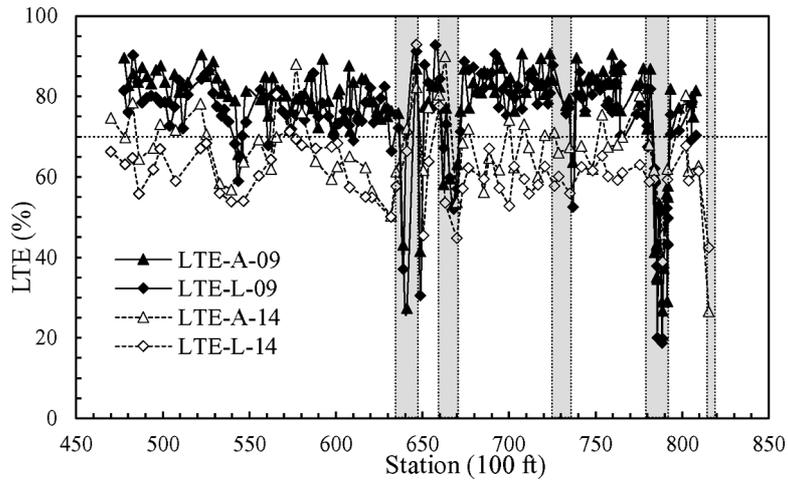
**Figure 10** (a) Distressed section (EB) LTE and (b) control section (WB) LTE (100 ft = 30.5 m) (T = pavement surface temperature)

Figure 10 shows the LTE results of selected test sections. LTE is generally poor on the distressed section. Most joints have LTE less than 70% and greater variation joint to joint; in some joints the LTE less than 20%. This indicates the dowels are ineffective. The control joints showed satisfactory LTE; only one joint had LTE at 70% or less. The temperatures during testing are 77°F (25°C) in distressed section (EB) and 88°F (31°C) in control section (WB), which are relatively high and slab expansion would have tended to lead to joint interlock, which would improve LTE, thus the joints with low LTE would be expected to have even lower LTE at lower temperatures.
